Hawaiian Volcanoes During 1951

GEOLOGICAL SURVEY BULLETIN 996-D

By GORDON A. MACDONALD and CHESTER K. WENTWORTH

*A report of the Hawaiian
Volcano Observatory*

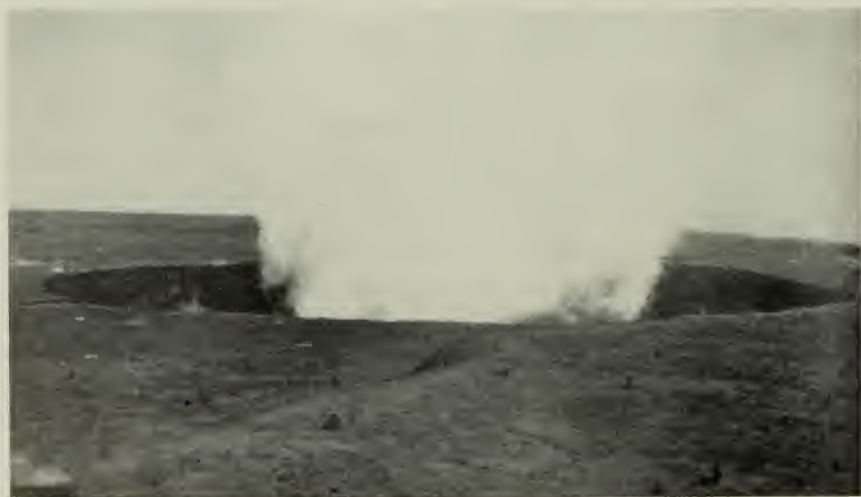
FIGURE 38.—Clouds of steam rising from Halemaumau on October 29, 1951, following heavy rains on the preceding 2 days. The view is from the Hawaiian Volcano Observatory, at Uwekahuna.

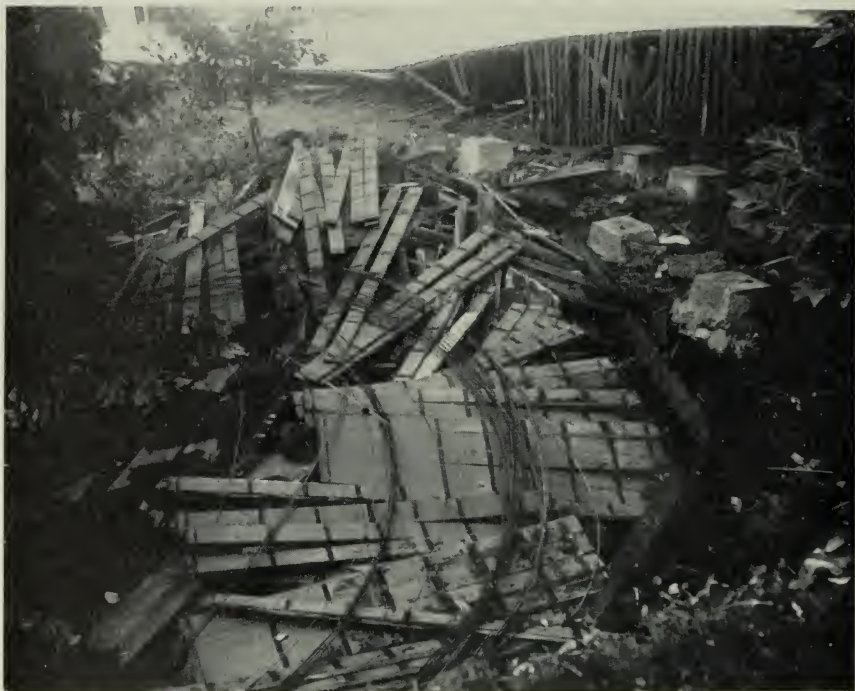
the length of the building were entirely adequate, but there was comparatively little bracing parallel to the width of the building, and some of this bracing was fastened, not to joists, but to floorboards. As a result, the underpinning was deficient in stiffness parallel to the ground slope. The direction of shaking during the earthquake was nearly parallel to this weakness in the structure, and the swaying caused the underpinning to fail in part and allow the building to slump downhill onto the ground (fig. 44). The building is a total loss.

FIGURE 44.—Honaunau School building from the southwest. All but the south end of this building was dropped and moved westward owing to inadequate bracing of the underpinning in an east-west trending direction transverse to the longer dimension. The wood-stave water tank collapsed and was thrown westward from its concrete-block footings.

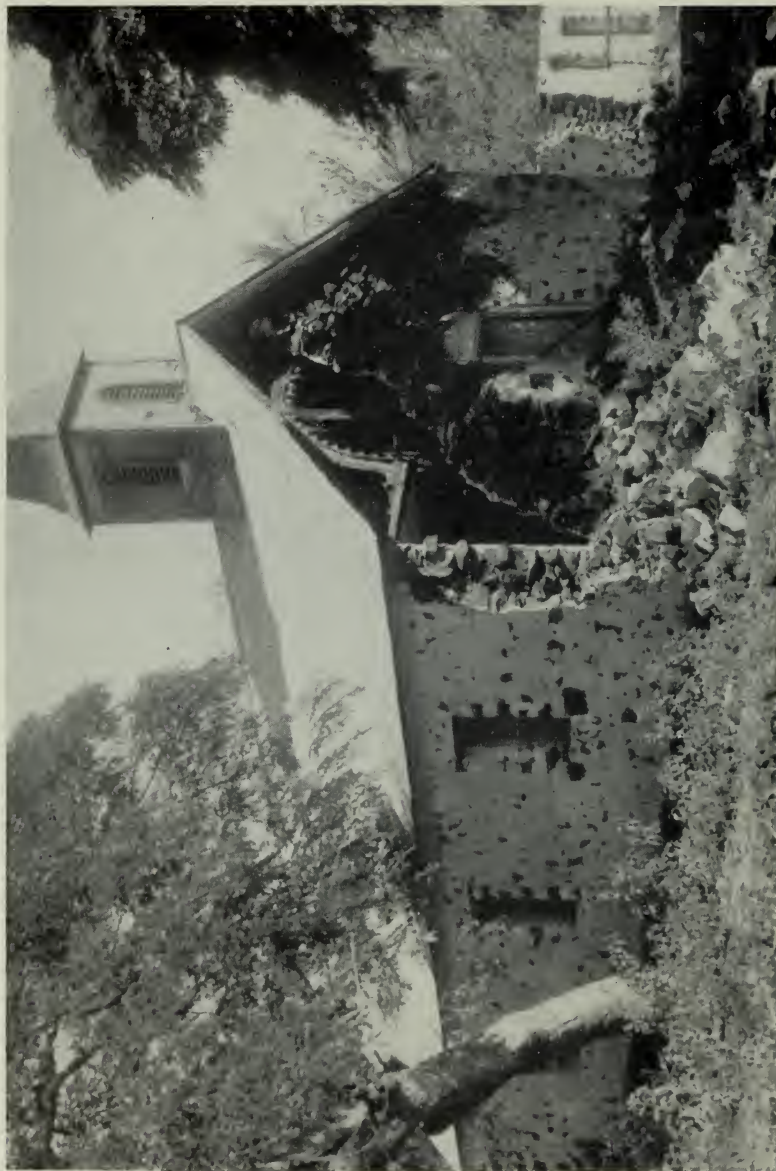
Several church buildings in the area near the epicenter were constructed with masonry walls. Most of these walls suffered some cracking, and others were seriously damaged. The masonry consists of fragments of lava rock laid with mortar made by calcining coral limestone. In some there was very little mortar in the inside parts of the wall. Most of the buildings were more than 95 years old.

FIGURE 45.—Church at Puu, 0.6 mile north of Hookea, viewed from the northwest. The western and eastern walls of the building were damaged. The severe damage at the northwest corner of the church building and of the old unroofed building beyond it, suggest displacement of the walls toward the northwest in the direction of the epicenter.

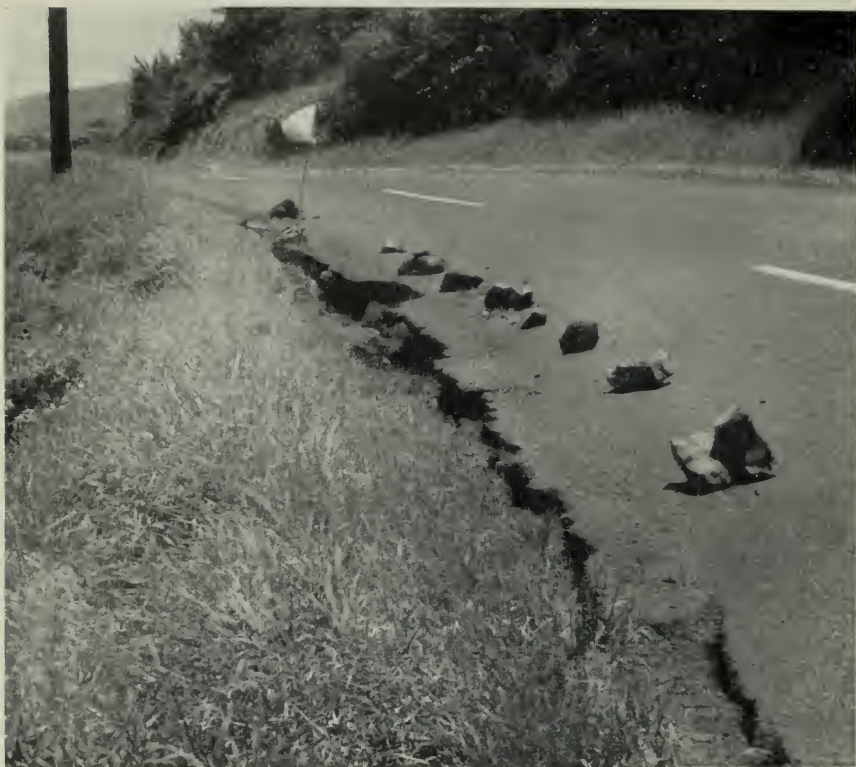
A common occurrence was the formation of a crack parallel to the edge of the pavement on its downslope side, either within the pavement a few inches from its edge, or between it and the shoulder (fig. 46). Some of these cracks were as much as 75 feet long and 8 inches wide. This apparently resulted from a downslope lurching of the shoulder that moved as a separate unit from the portion of the fill

FIGURE 46.—Crack along the edge of the highway pavement 2 miles south from Kaimalino, apparently resulting from a downslope lurching of the shoulder, which moved as a separate unit from the part of the fill beneath the pavement.

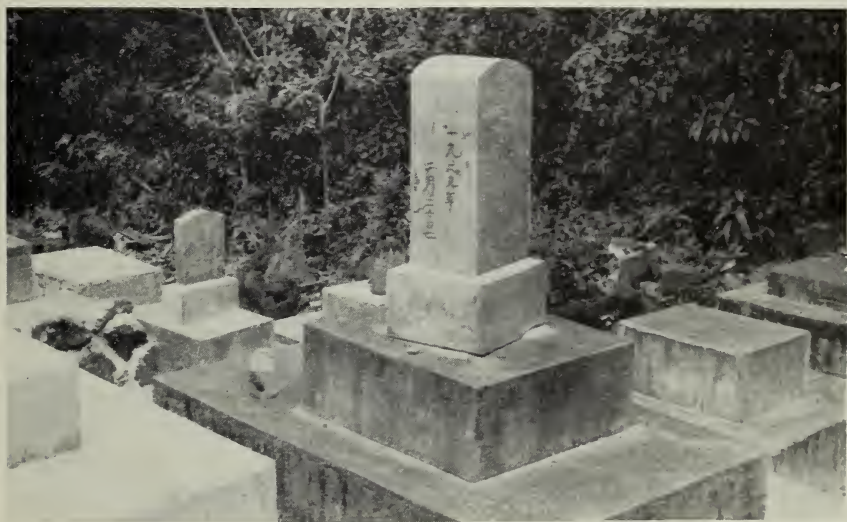
Derangement of headstones included overturning of stones (fig. 47), and shifting of stones on their bases with or without rotation. Many grave caps were broken, some by falling or disturbance of headstones, and some by lurching or slumping of the adjacent subsoil.

FIGURE 47.—Gravestone rotated counterclockwise, in the Daifukuji cemetery at Honalo. Other stones have been thrown from the vacant bases visible in the photograph and are out of sight behind the bases.
